CITY OF MISHAWAKA HISTORIC PRESERVATION COMMISSION

certificate of appropriateness

Location: 2426 Riviera Drive

Certificate of Appropriateness: 18-01

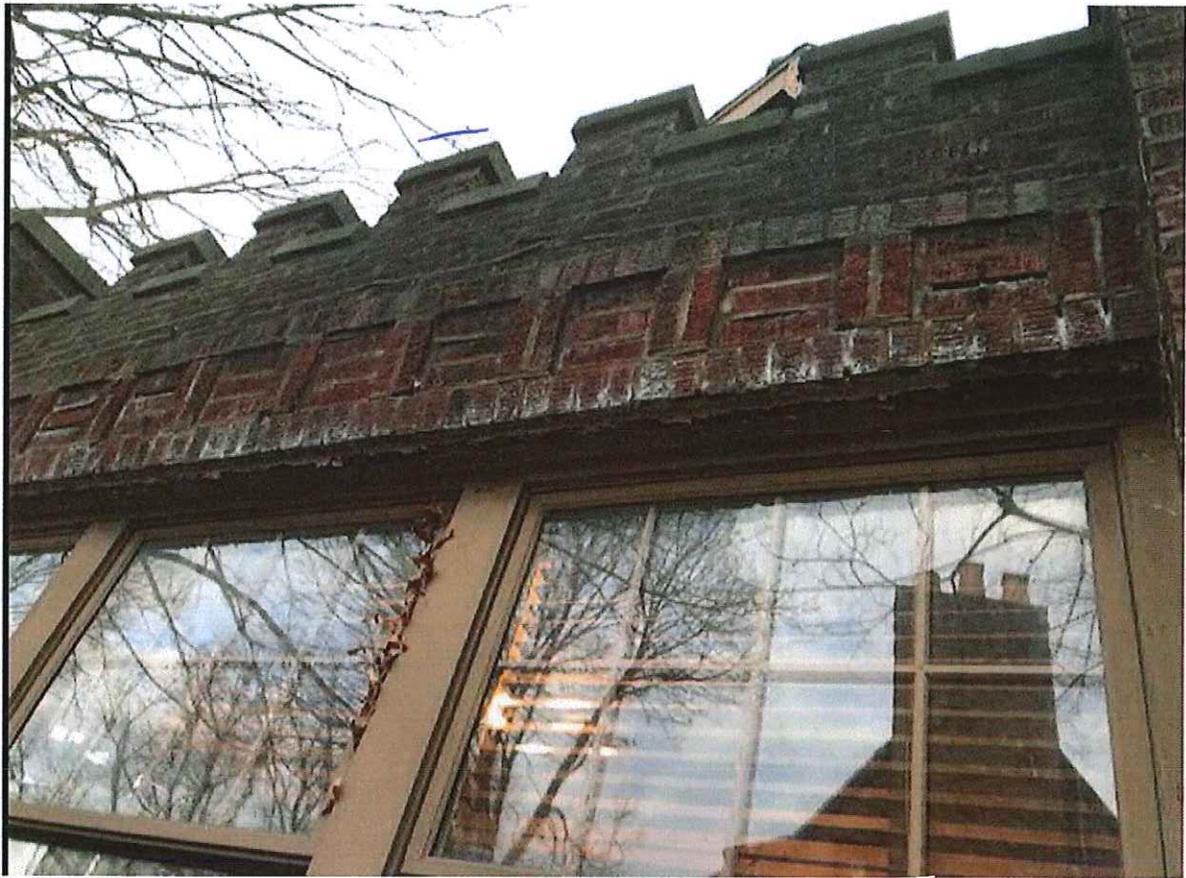
SAW TOOTH PARAPET ABOVE ENCLOSED PATIO **A**

- Take down brick to top of windows. Clean brick for reuse.
- Replace steel lintels over windows. Install flashing & weep joints.
- Relay brick. Approximately 1300 brick. (w/ historic mortars)
- Wash & seal. Approx 12 Days of labor \$15,070.00

The first item on the Hershberger Masonry quote is to take down brick on the saw tooth parapet above enclosed patio to the top of windows (see Exhibit A for detail). The steel lintels over the windows will be replaced. The windows are not being replaced at this time, because the structural problem was more imperative, but the Applicant would like to include the window replacement on the enclosed porch in this COA. The same bricks will be used with historic mortar. A similar process will be done on the second story saw tooth parapet wall. Item 2 on the quote is replacing the steel lintels, brick and limestone on 2 basement windows. The last item on the quote is to take the chimney down to roof level, clean and relay bricks, adding a new 4" thick concrete cap on top.

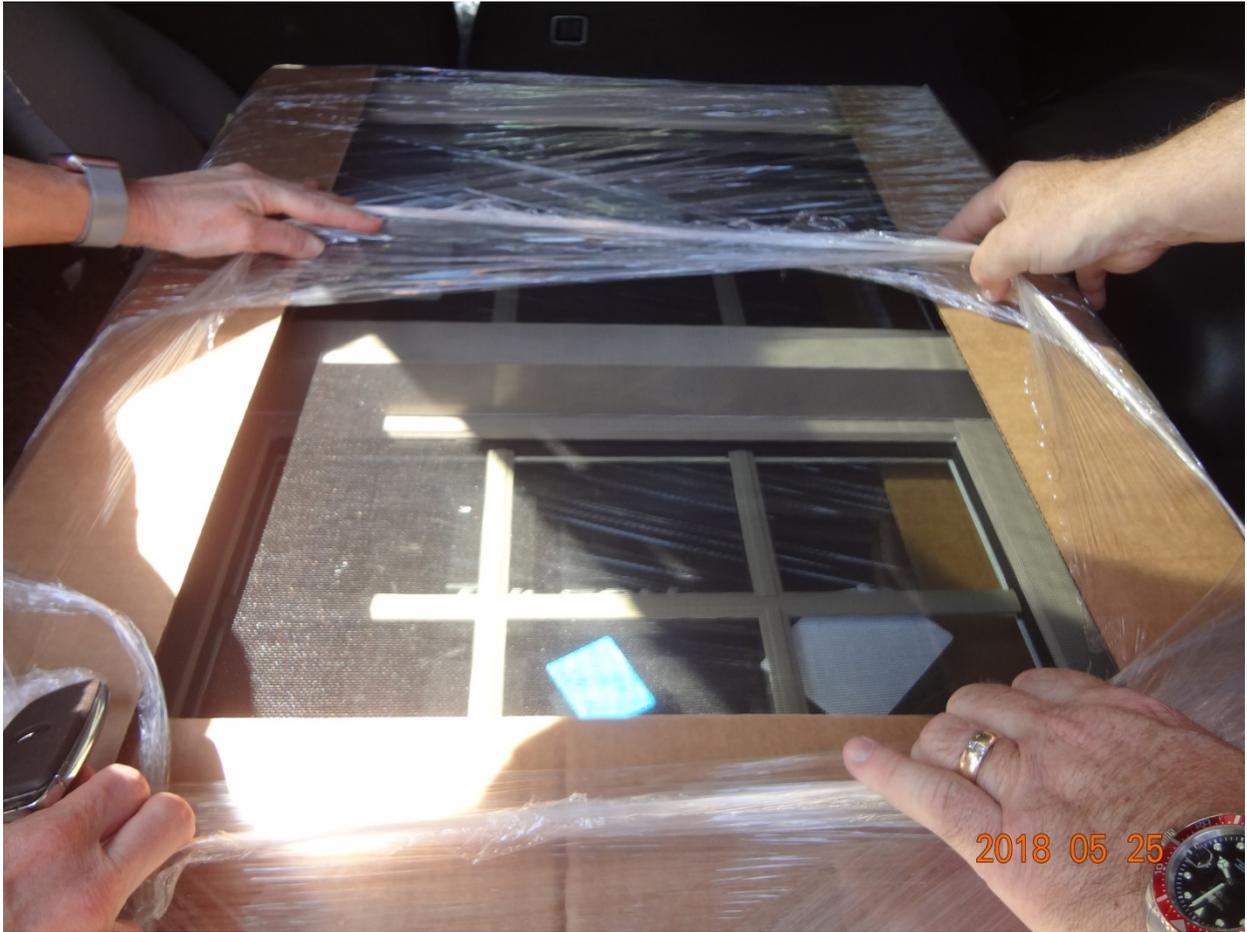
Picture of Replacement Window

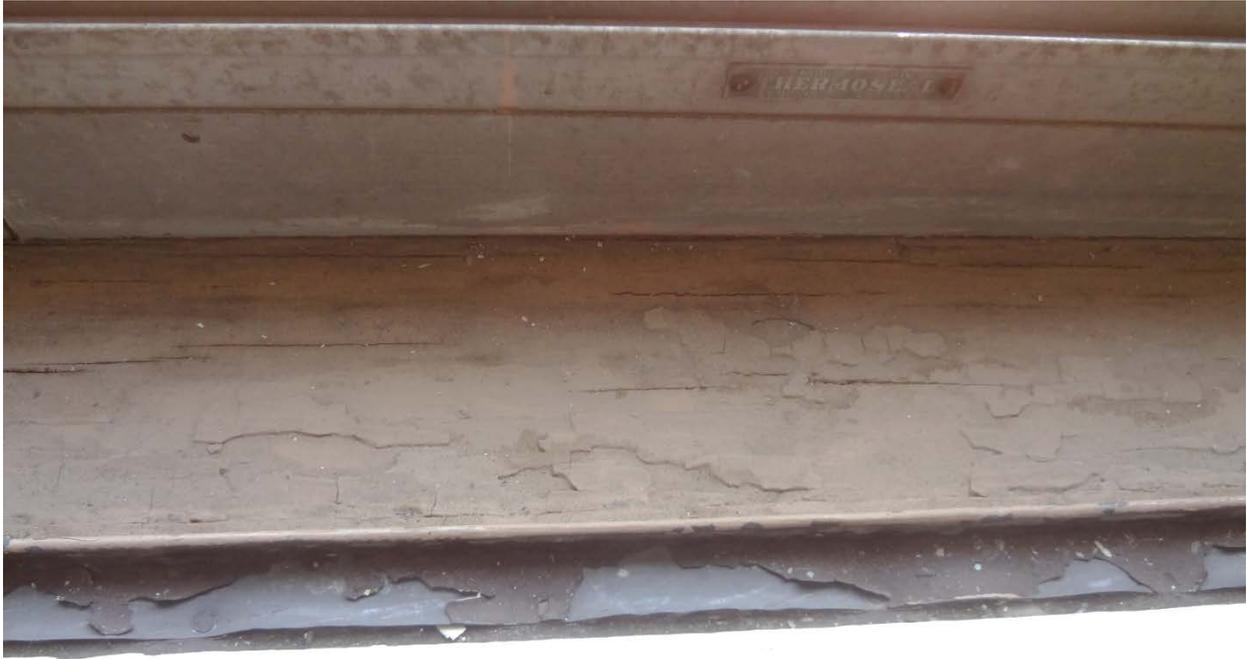
Staff Picture of peeling paint on windows

The Applicant is also requesting a Certificate of Appropriateness for window replacement. The description of work is the removal of aluminum storm windows; and removal and replacement of windows with energy efficient windows of the same design (e.g. 6 over 6 and 8 over 8) as the original windows. Original windows have lead in them that is a health risk, the wood is rotten on many and most are missing the weights. The replacement windows will be Quaker Brand, the same brand that was used

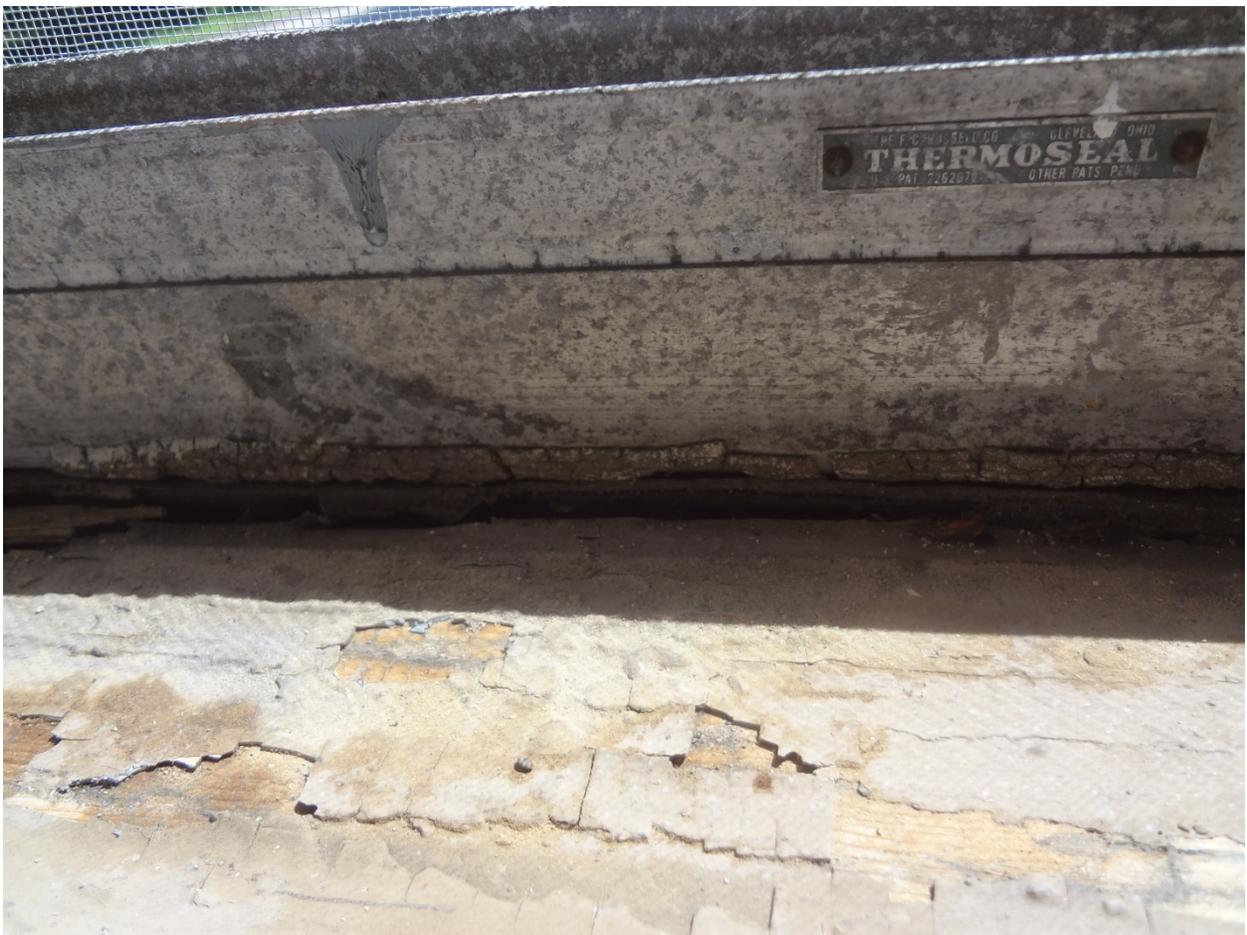
Staff Picture of peeling paint and rotting wood on windows
